INSPECTION REPORT

For the Property at:
260 MANNING AVENUE
TORONTO, ON M6J 2K7

Prepared for: LUKE NICHOLSON and MEL KELLY
Inspection Date: Tuesday, March 5, 2024
Prepared by: Tim Palmer

Report No. 2755

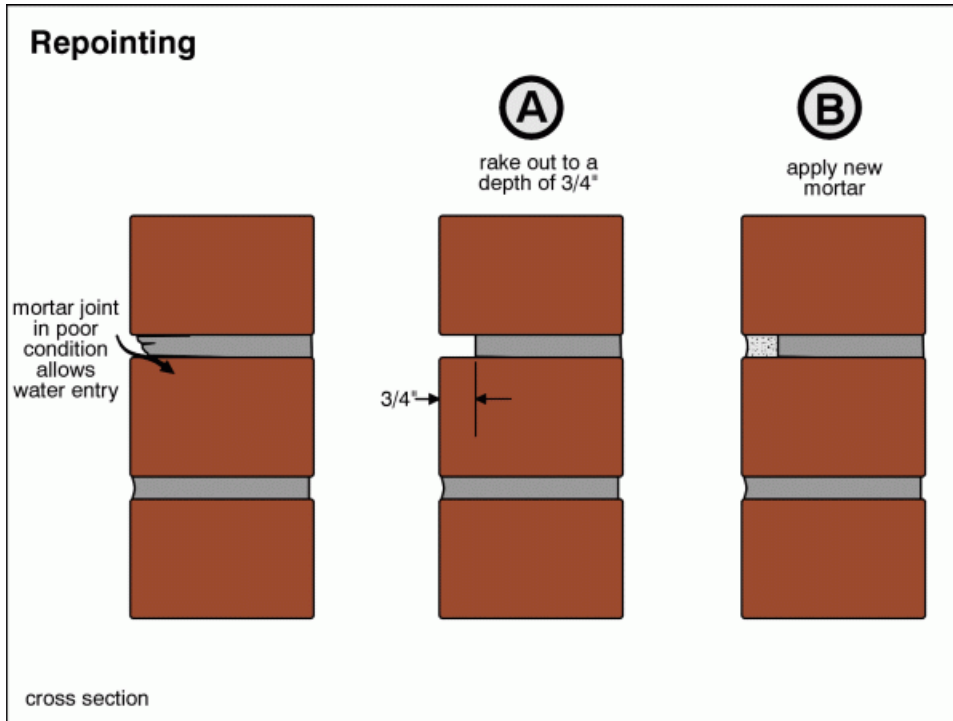
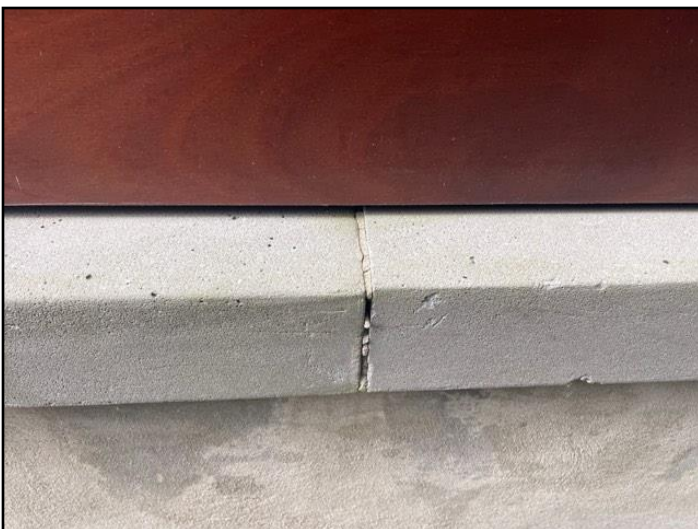
1. **Condition:** • Mortar deterioration

Implication(s): Chance of water entering building | Weakened structure | Chance of structural movement

1. Mortar deterioration

Task: Consult a qualified professional

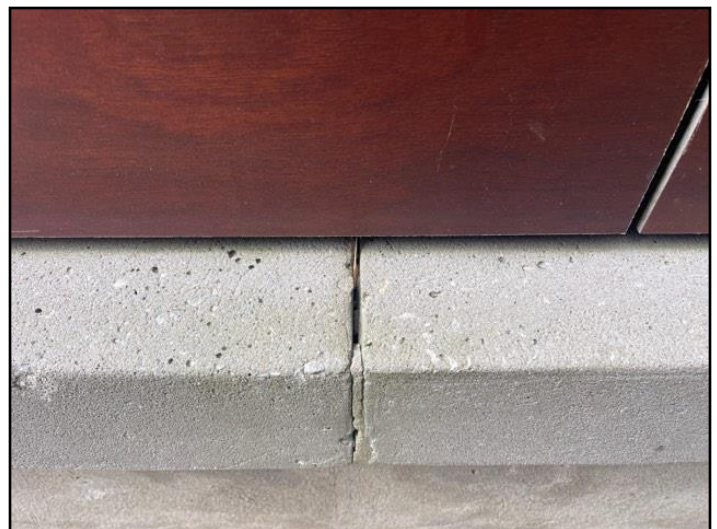
2. Mortar deterioration

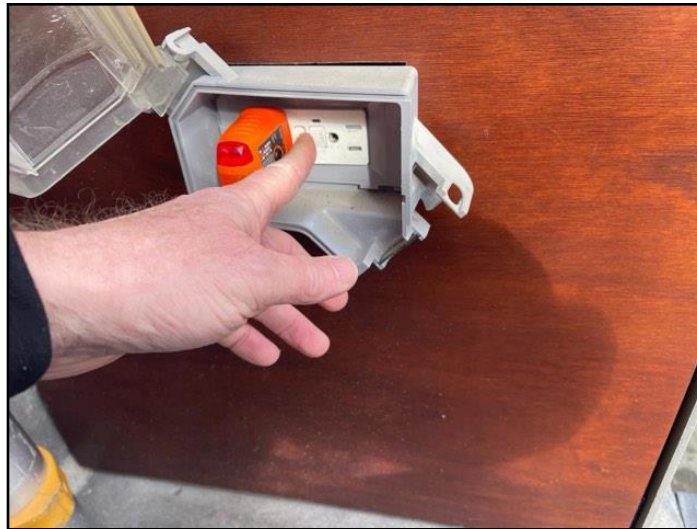
4. Condition: • Test faulty on GFCI/GFI (Ground Fault Circuit Interrupter)

Implication(s): Electric shock

3. Test faulty on GFCI/GFI (Ground Fault...

Task: Replace

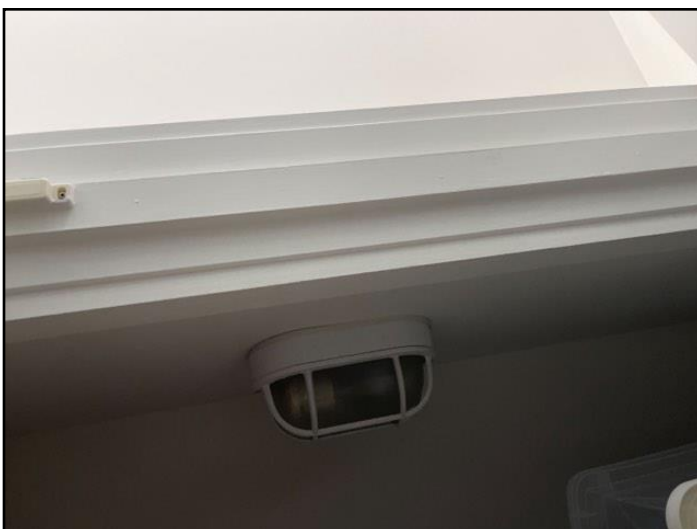
5. Condition: • Inoperative

Location: Second Floor Bedroom Closets

4. Inoperative

Task: Correct

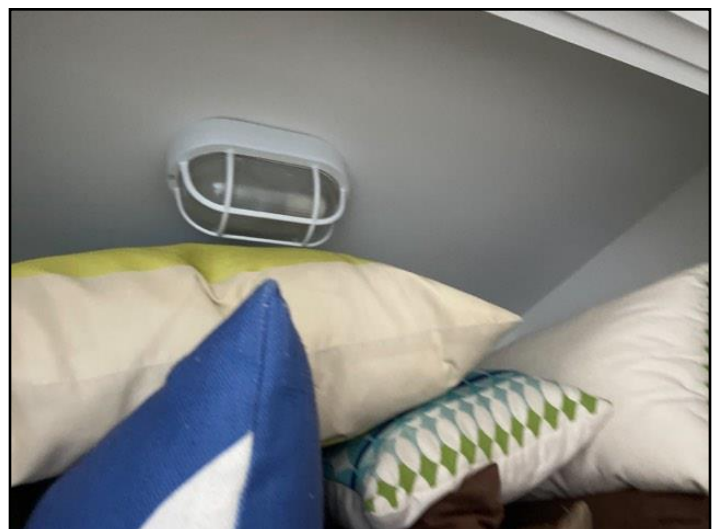
5. Inoperative

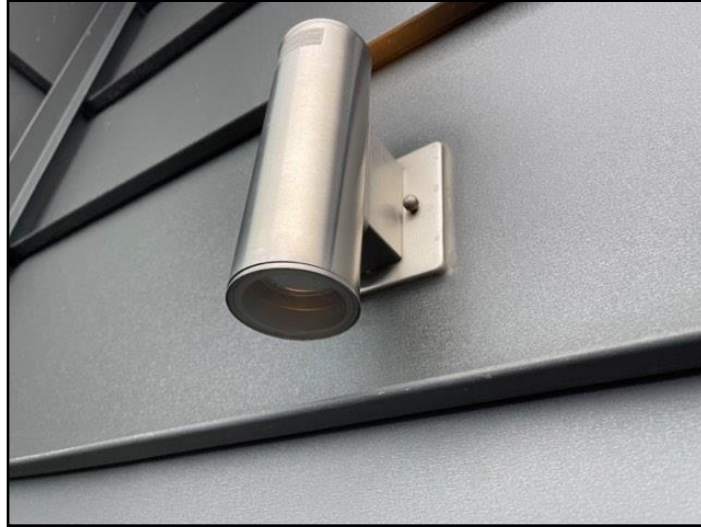
6. Condition: • Inoperative
Implication(s): Inadequate lighting
Location: Third Floor Balcony
Task: Replace
Time: When necessary

6. Inoperative

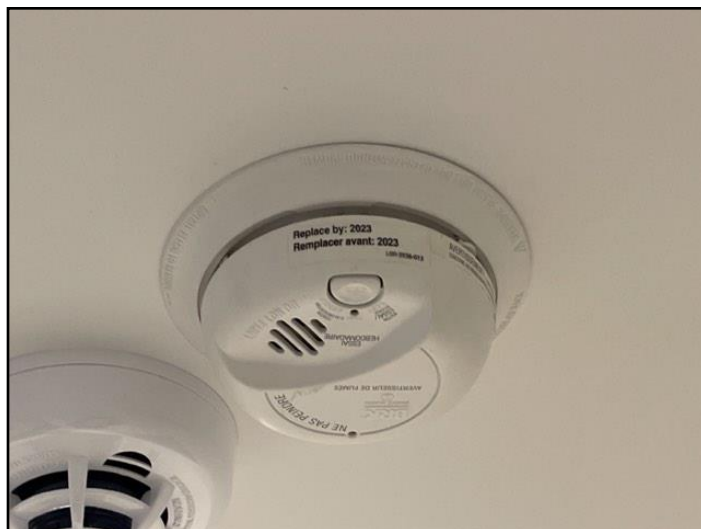
7. Condition: • More than 10 years old
Recommend replacing with combination smoke and CO units on all floors where required.
Some require replacement in the next few years but recommend updating of all units regardless.
Implication(s): Life safety hazard
Location: Various
Task: Replace
Time: Immediate

7. More than 10 years old

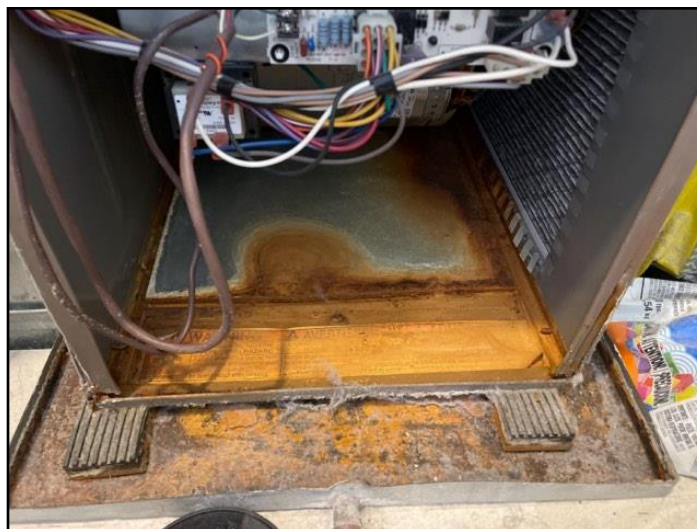
9. Condition: • Rust

Implication(s): Material deterioration | Reduced system life expectancy

10. Rust

Task: Service

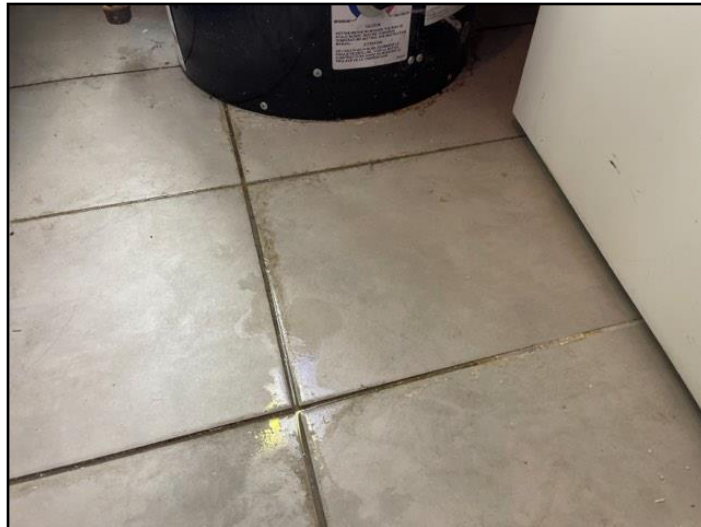
10. Condition: • Leak

Implication(s): Chance of water damage to structure, finishes and contents

17. Leak

Task: Replace

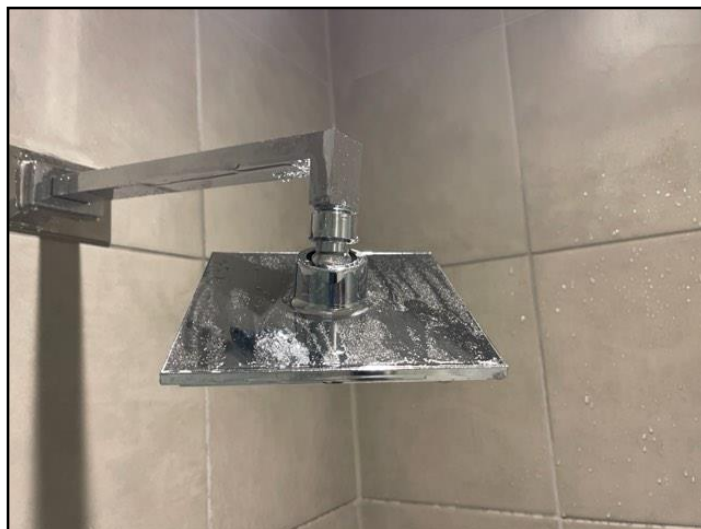
11. Condition: • Shower head damaged

Implication(s): System inoperative | Reduced water pressure and volume

18. Shower head damaged

Task: Repair or replace

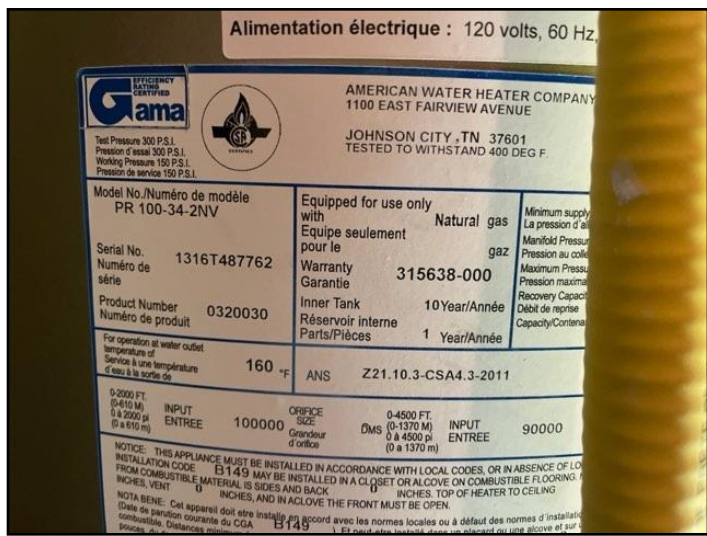
19. 11 years

- Water heater typical life expectancy:** • 10 to 15 years
- Water heater failure probability:**
 - High
- Leaking
- Hot water temperature (Generally accepted safe temp. is 120° F):**
 - 130° F
 - Chart

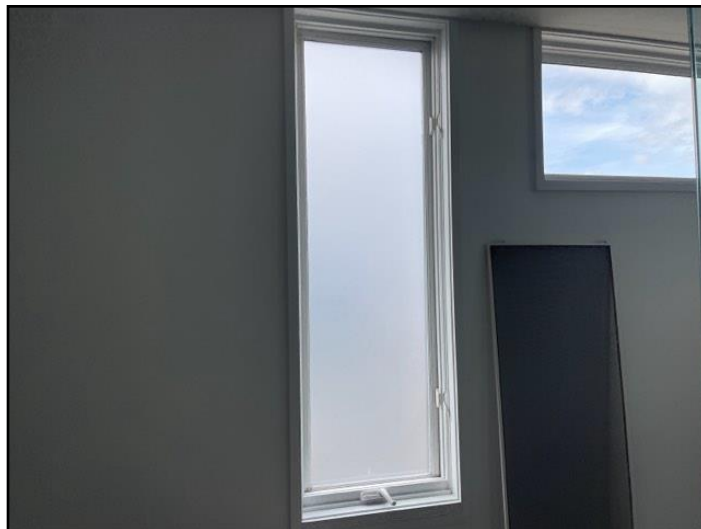
12. Condition: • Difficult to operate
Implication(s): System inoperative or difficult to operate
Location: Third Floor Ensuite Bathroom
Task: Repair
Time: As soon as practical

21. Difficult to operate
